King George County, Virginia Shoreline Inventory Report: Methods and Guidelines

King George County, Virginia Shoreline Inventory Report Methods and Guidelines

Prepared By:
Comprehensive Coastal Inventory Program
Center for Coastal Resources Management
Virginia Institute of Marine Science, College of William and Mary
Gloucester Point, Virginia
September 2017

Special report in Applied Marine Science and Ocean Engineering **No. 461** of the Virginia Institute of Marine Science

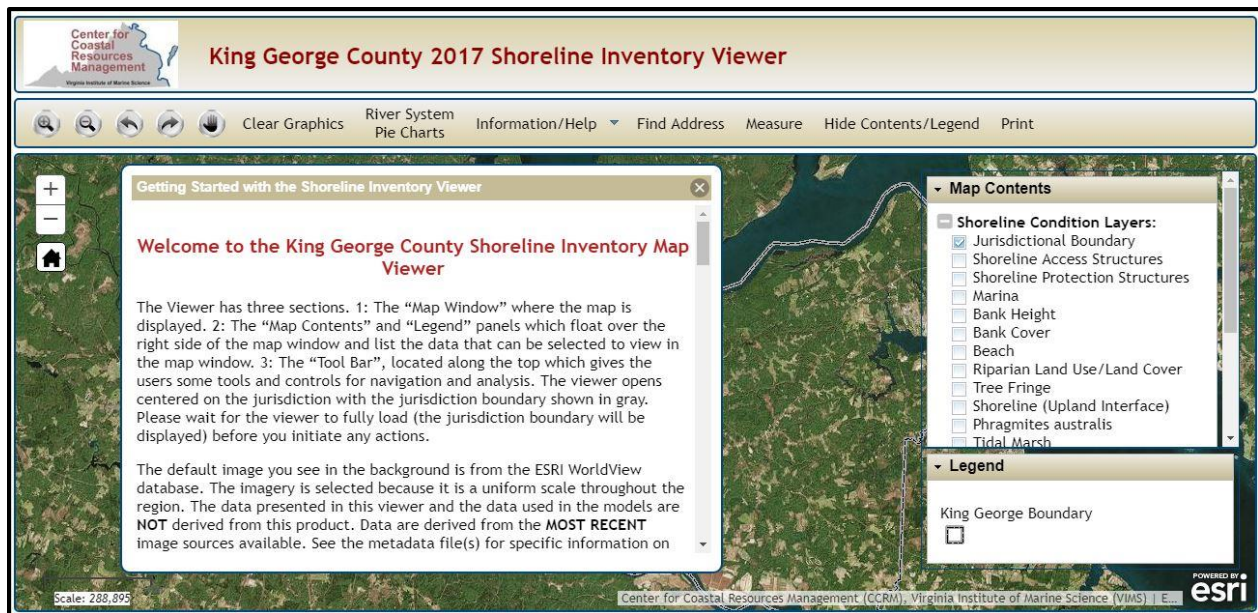
Figure 3. Opening page for the King George County Shoreline Inventory Viewer

The Viewer has two panels: “Map Window”, where the map is displayed and “Map Contents and Legend”, where data that can be selected and viewed in the map window are listed. A tool bar is located along the top of the “Map Window” which gives users some controls for navigation and analysis (Figure 3.).

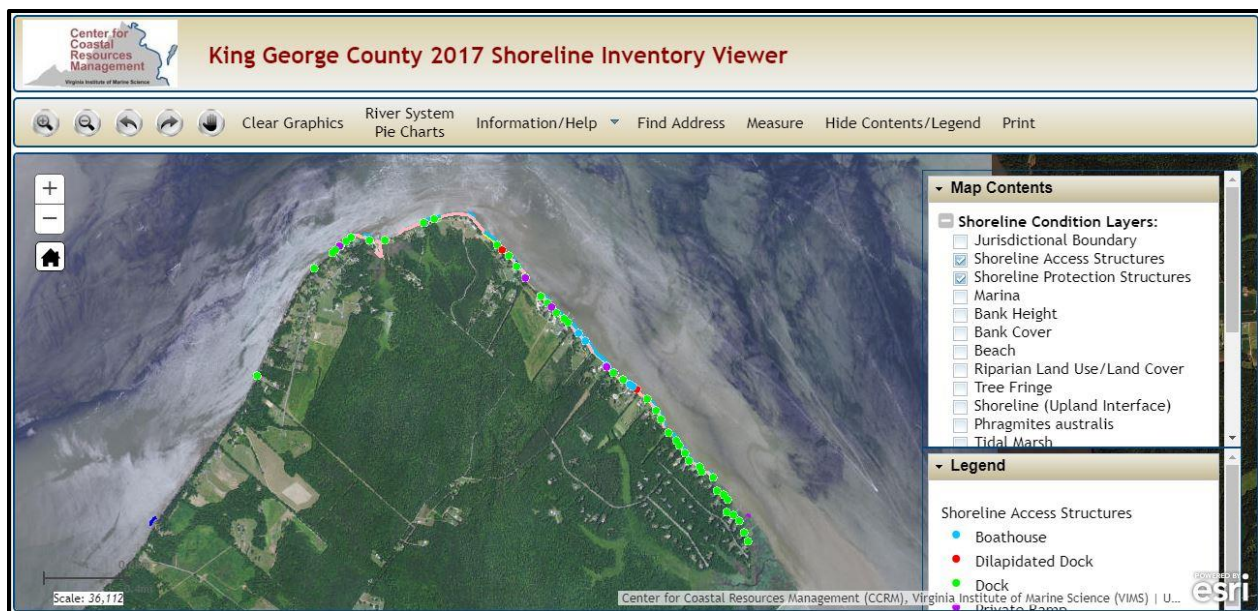
Figure 4. Map Viewer illustrates Shoreline Access and Protection Structures for a section of King George County.

In Figure 4 Shoreline Access Structures, and Shoreline Protection structures are selected. Shoreline Access structures are point features that includes piers and boat ramps. The actual footprint of these structures is not measured; only their location. Shoreline Protection Structures are line features and are mapped and illustrated in the viewer to show where they occur along the shoreline. Figure 5 illustrates riparian land use in the riparian zone for the same section of the County.

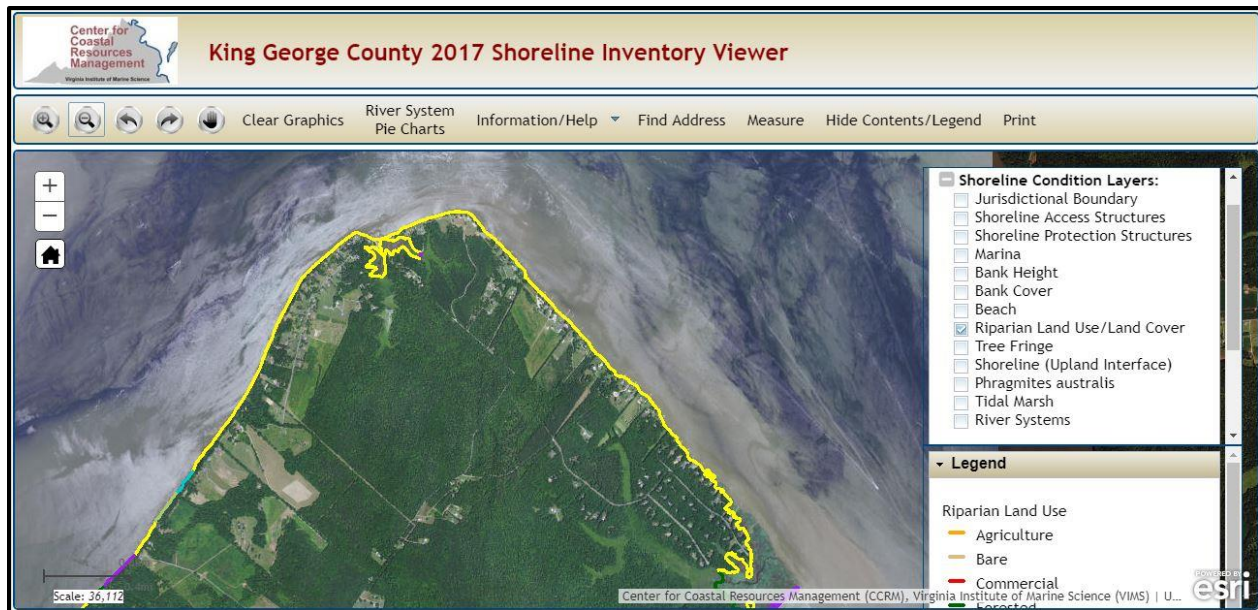
Figure 5. Distribution of land use in the riparian zone is displayed for this region of King George County.

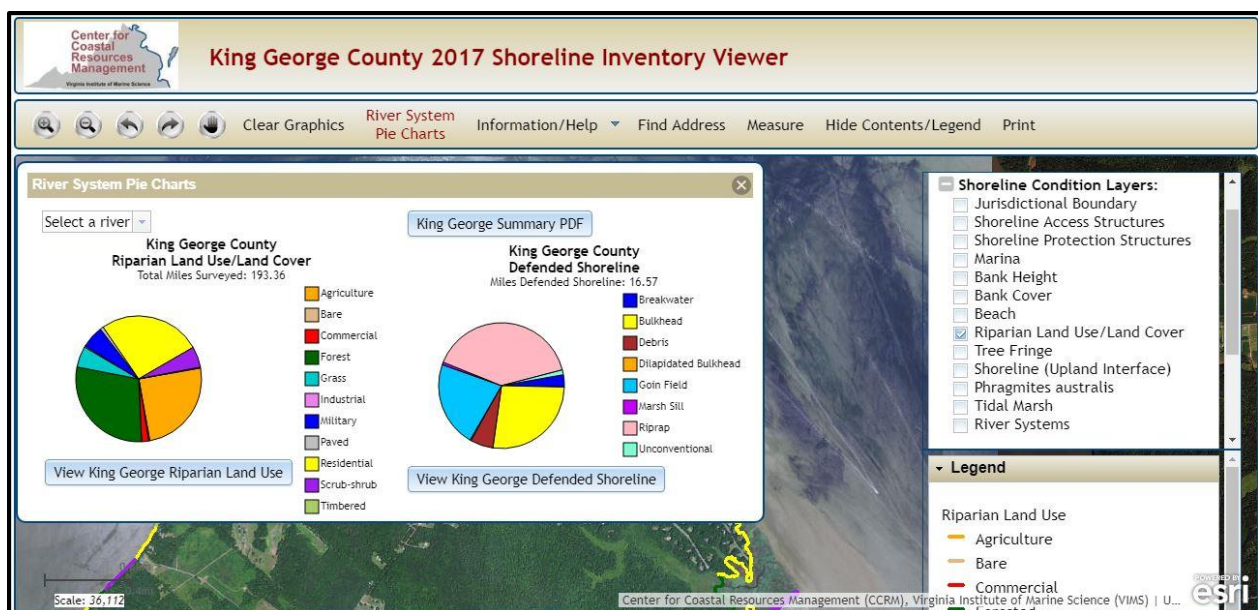
Figure 7. Pie charts display land use and shoreline hardening statistics for each tributary.

The top toolbar also includes tabs to access some important status information for the locality. By clicking on the “River System Pie Charts” button, users can obtain a statistical summary distribution of the riparian land use and amount of hardened shoreline for a specific water body selected from the drop down menu in the upper left (Figure 7). More detailed results in table format can be found by clicking the King George County Summary PDF button also in the window. The summary statistics are reported by river systems (Figure 2).

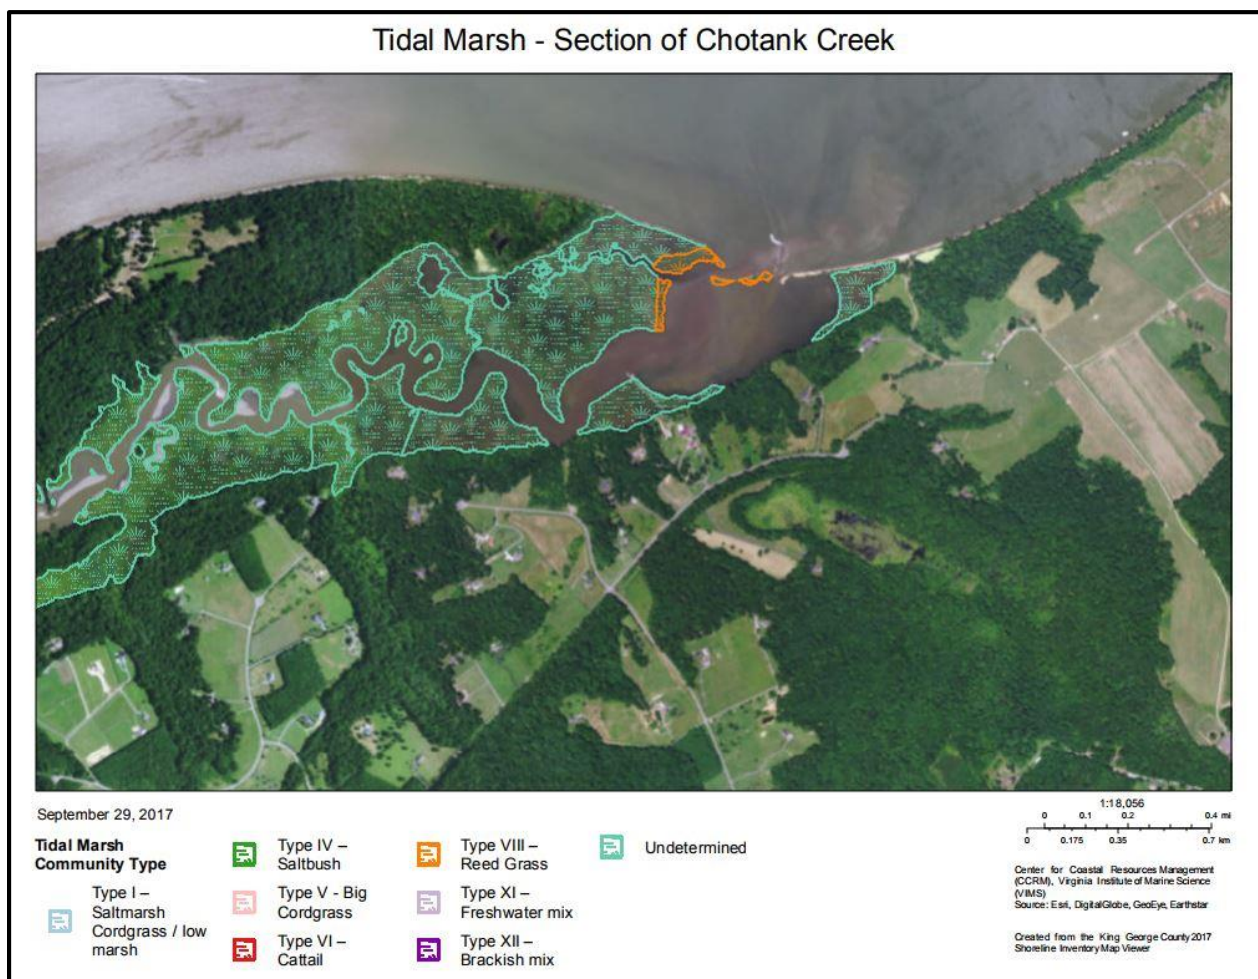
Figure 8. Customized print window for a section of Chotank Creek

Finally, users have the option to personalize their own maps (i.e. map extent, data displayed, map title, etc.) and save them as a pdf file by clicking “Select Print Layout” button. The page can be set up for printing to 8.5 x 11 portrait or landscape style. Figure 8 is an example of a customized map generated for a section of Chotank Creek. Here the tidal marsh communities are displayed, and the community type is reported in the legend beside the illustration.
